Inspection Report

ITHACA
BUILDING & PEST INSPECTIONS

Inspection Date: 02 Aug 2018

TIMBER PEST INSPECTION

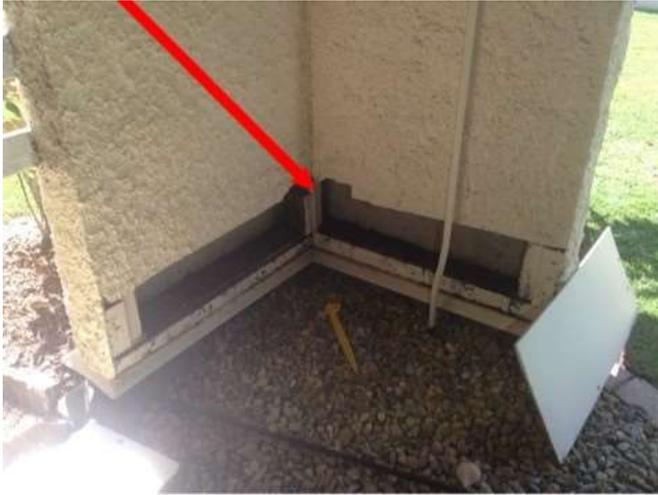
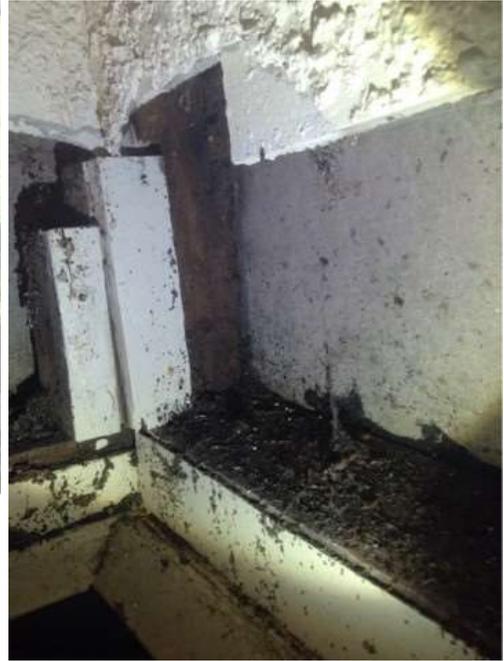
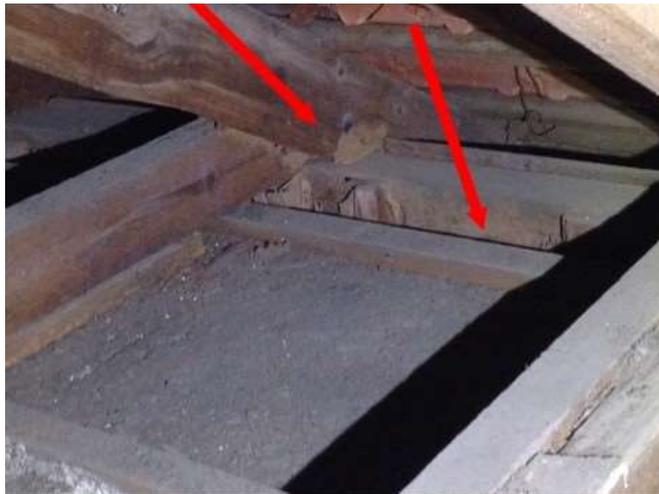
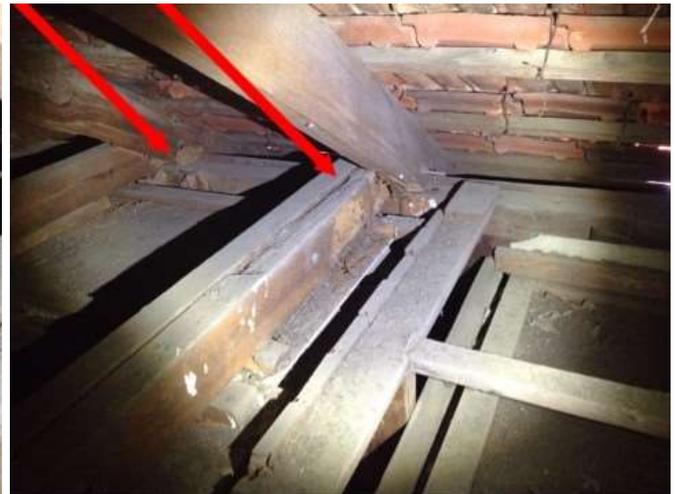
Was there any Termite Workings or Damage Found

Yes - Read this report in its entirety.

Note: Any evidence of termite activity or workings in the grounds or building structure assumes that risk to buildings is very high. We strongly recommend a treatment to eradicate the termites and to protect the building.

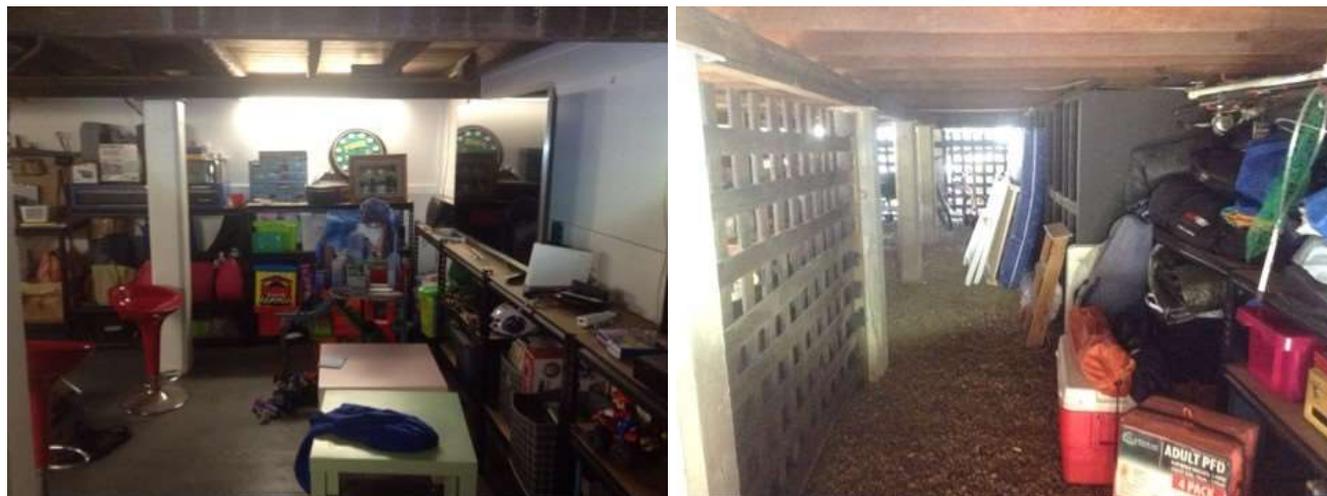
Sections of the sub floor could not be inspected due to - Stored items restricted entry.

It is strongly recommended that full access be granted to enable a thorough inspection to take place as it could be harboring timber pest activity and/or damage.

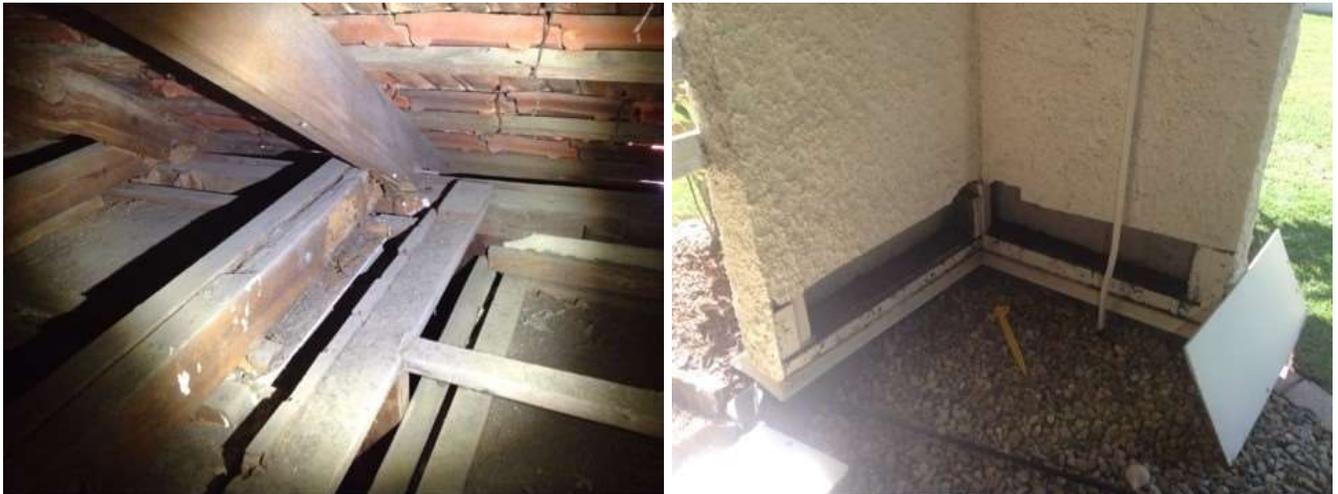
Yes, termite damage was found in the following

Roof frame timber

Mudding was observed in the subfloor timbers to frame under entry porch.

Where visual evidence of termite workings and/or damage is reported above, but no live termites were present at the time of inspection, you must realize that it is possible that termites are still active in the immediate vicinity and the termites may continue to cause further damage. It is not possible, without benefit of further investigation and a number of inspections over a period of time, to ascertain whether any infestation is active or inactive. Active termites may simply have not been present at the time of inspection due to a prior disturbance, climatic conditions, or they may have been utilizing an alternative feeding source. Continued, regular, inspections are essential. Unless written evidence of a termite protection program in accord with "Australian Standard 3660" with ongoing inspections is provided, you must arrange for a treatment in accord with "Australian Standard 3660" to be carried out immediately to reduce the risk of further attack.

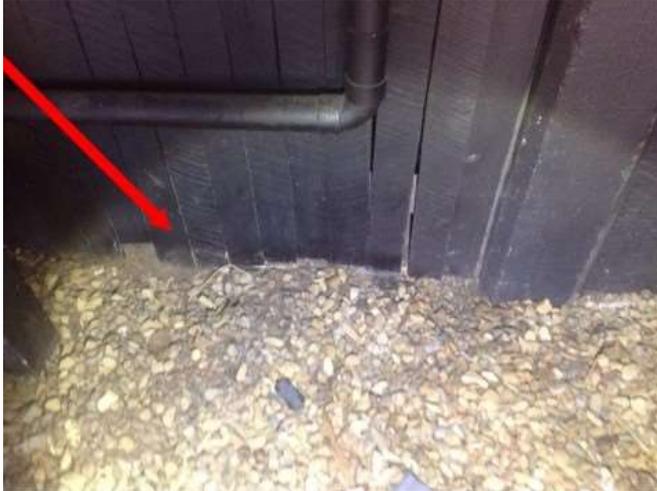
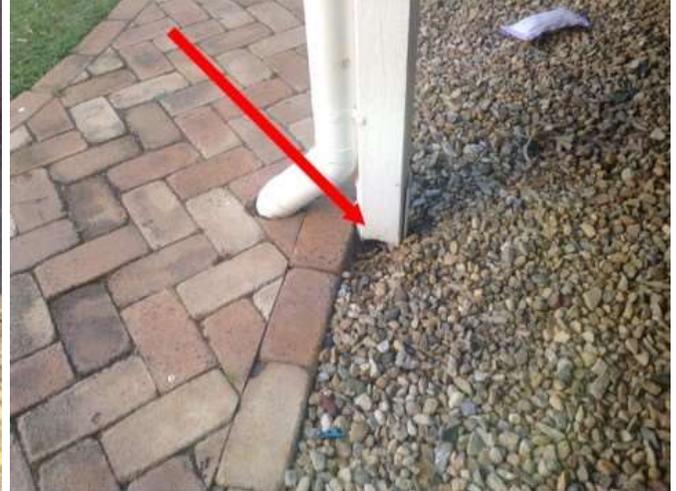
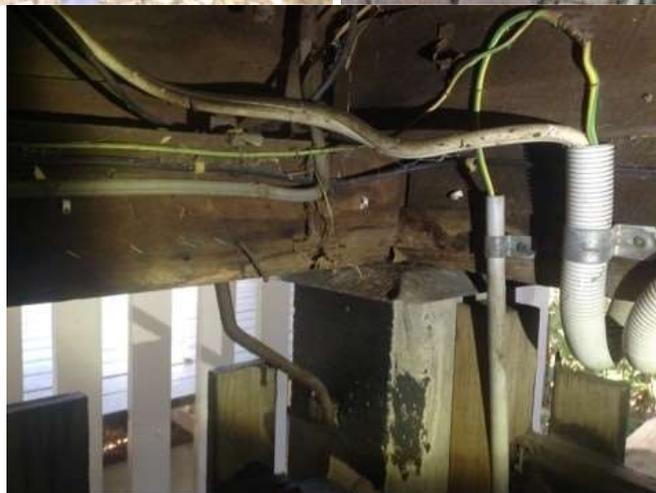
Yes, in the following areas ,
Exterior Wall Clad to sub floor
Balcony Post/s ,

Moderate Damage

If any evidence of fungal decay or damage is reported you should consult a building expert determine the full extent of damage and the estimated cost of repairs or timber replacement (see terms & limitations).

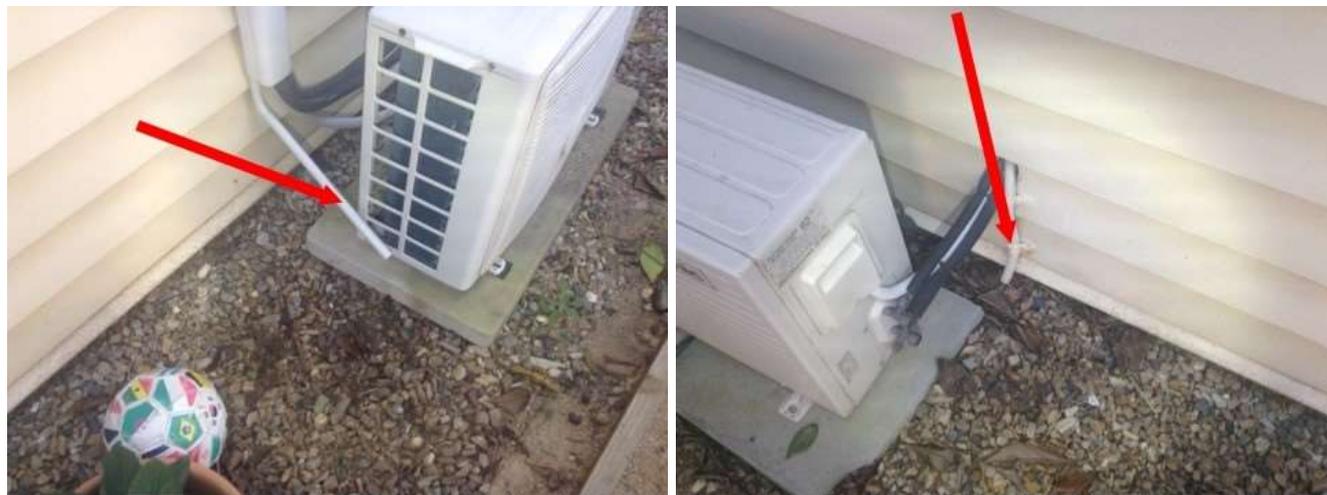
Was the Air Conditioner sufficiently drained

No - Divert A/C overflow away from the building perimeter

Wall mounted air conditioner overflow requires diverting to drain. This provides conducive conditions for termite infestation. Engage plumber to rectify.

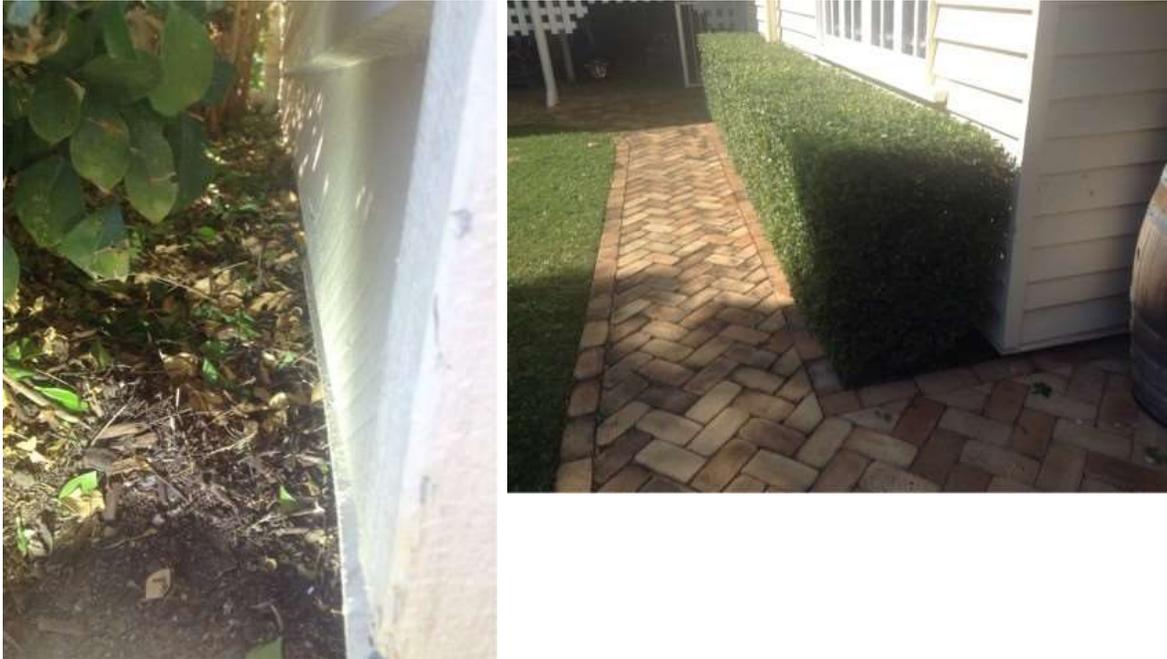
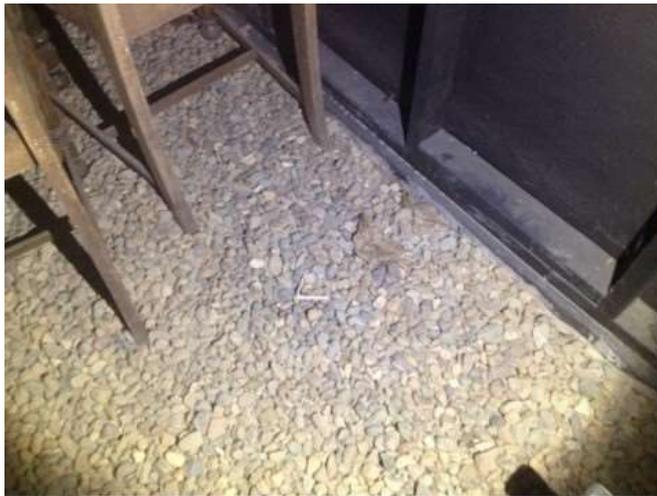
Is the slab edge adequately exposed

Yes in some areas.

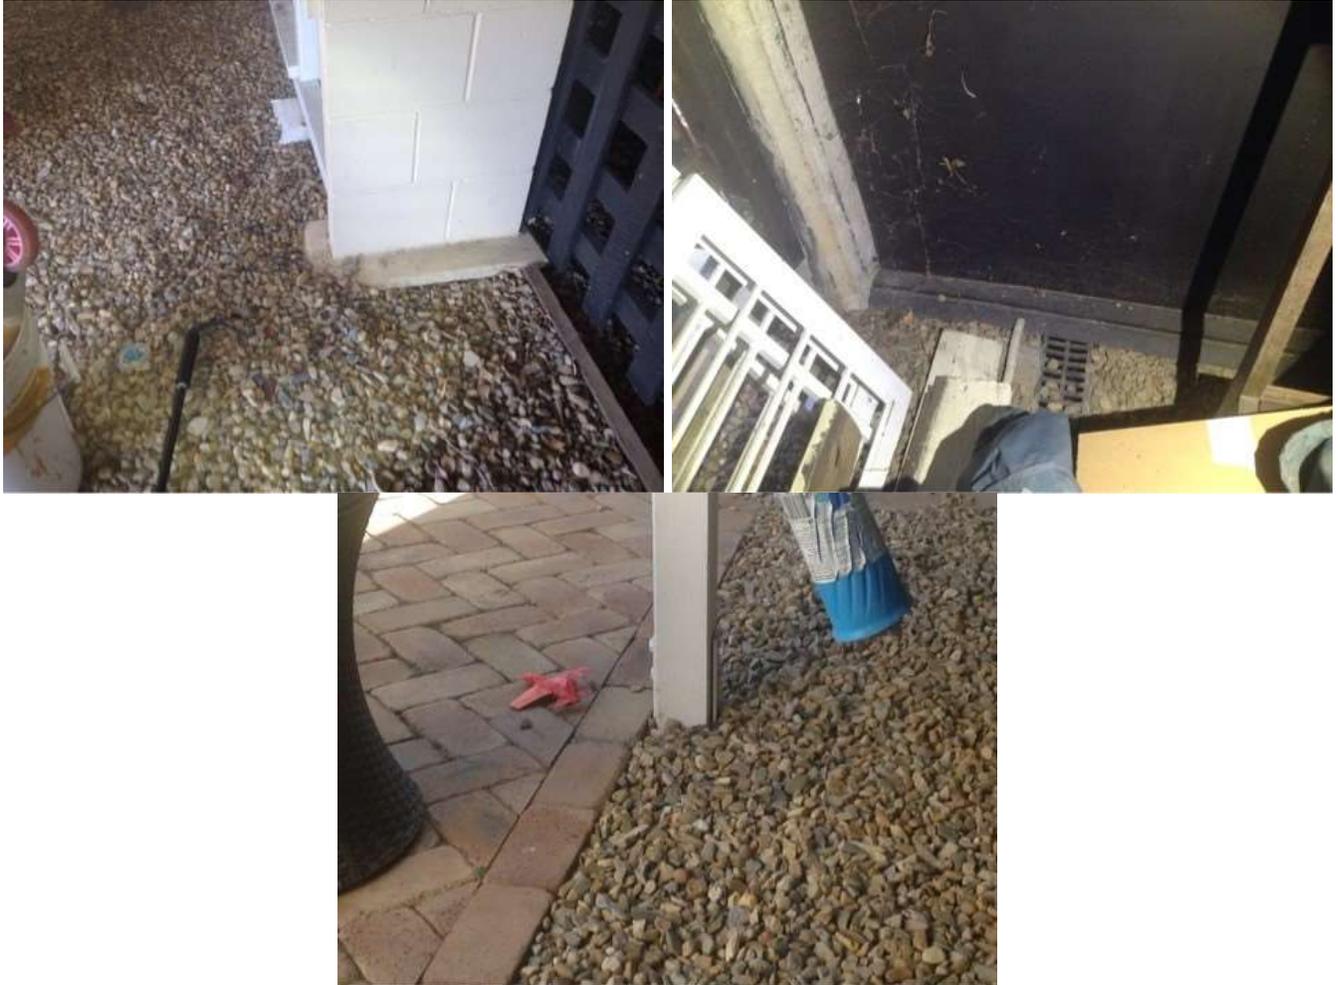
Timber framing in contact with ground in sub floor due finished ground levels high and being built close to ground. This provides conducive and concealed conditions and concealed entry for termite infestation. The degree of risk is high. Ground levels require lowering.
